Inspector Field Report

Project: Loma Vista Adult School
Emergency Electrical Cable Replacement

Date: 07-10-21

Date: 07-17-21

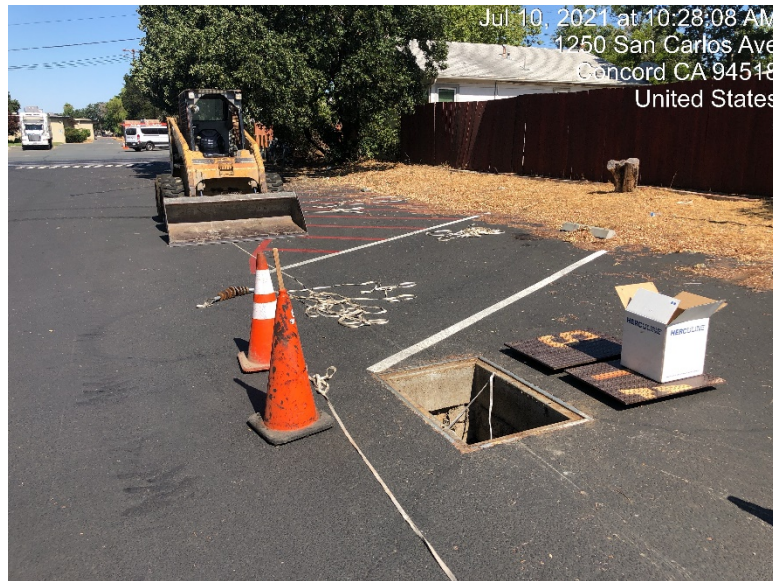
PT B pull box

The contractor has sawcut at pull box B in anticipation of removal. The new cables do not arrive until Friday the 16th.

The pull boxes in the parking lot are to be replaced with correct sizes/installation.

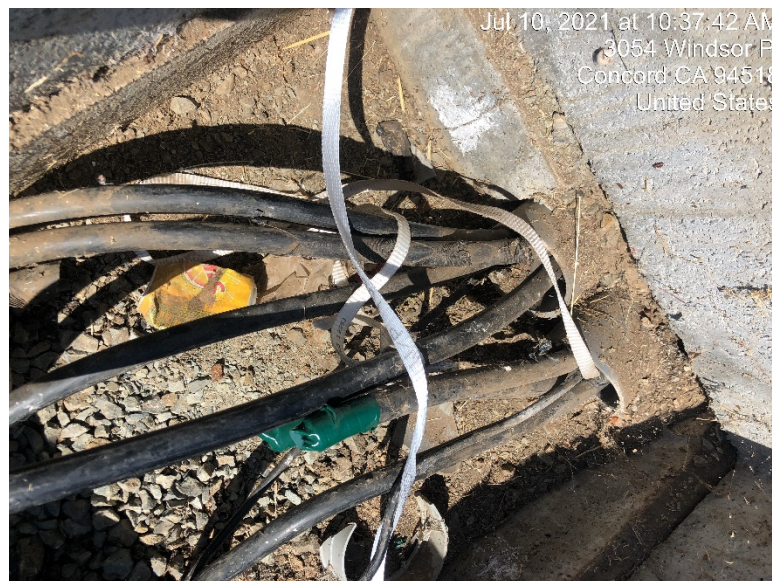
Existing 500 mcm's

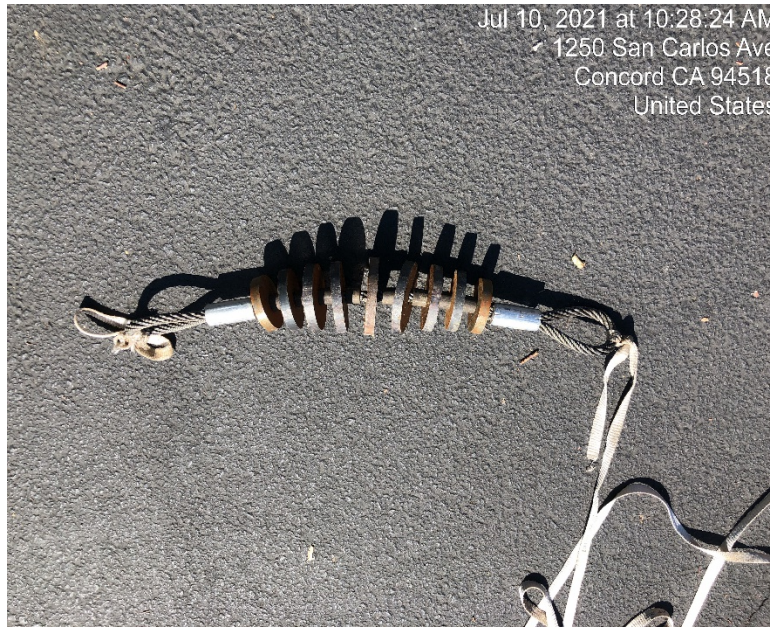
3" Mandrel

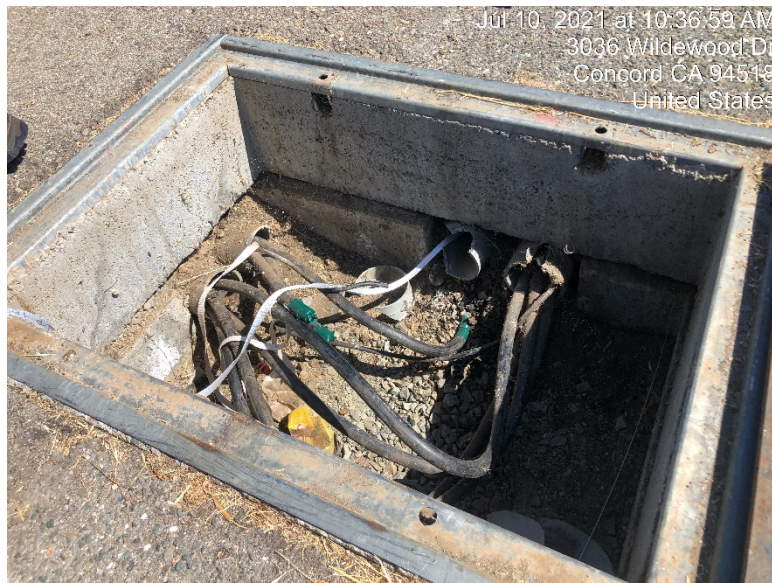
Existing pull box, conduit, and 500 MCM's (damaged)

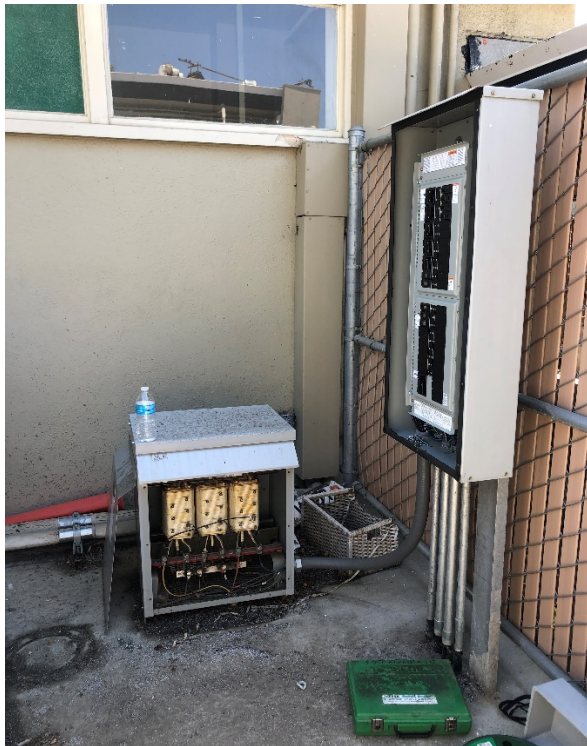
Panel LC and transformer (tied in)

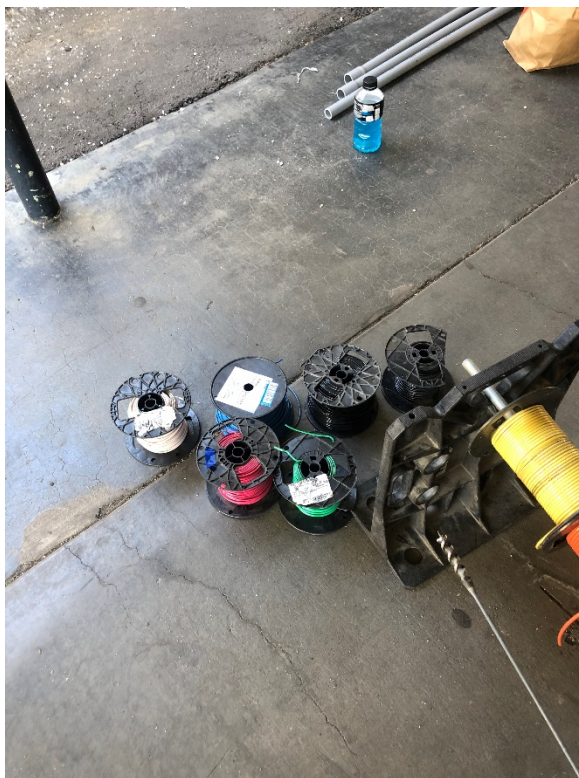
#12 AWG wire and #10 AWG (on spool)

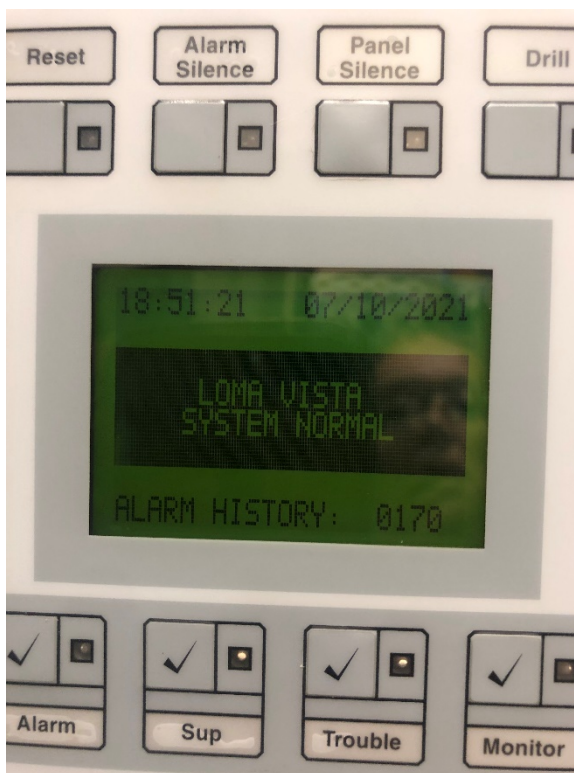
Fire alarm panel clear

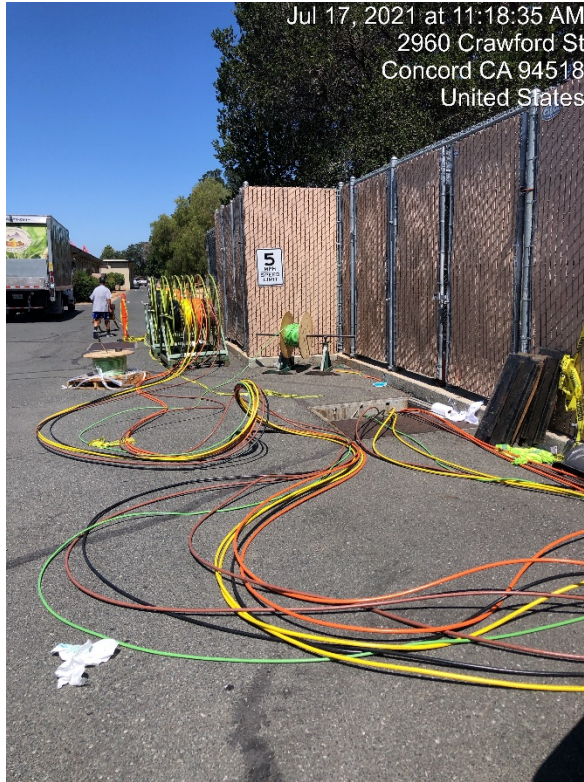
500 mcm laid out at main switch gear and Pt A

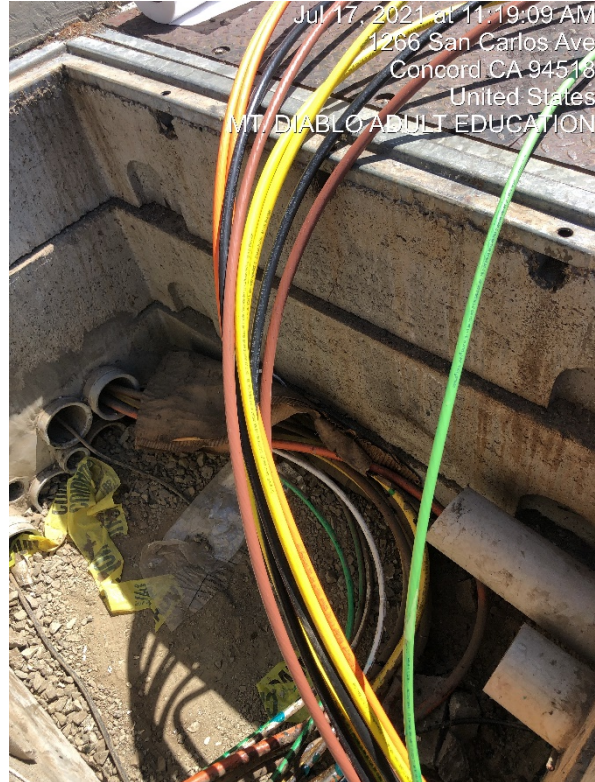
Cable for the new circuits (2)

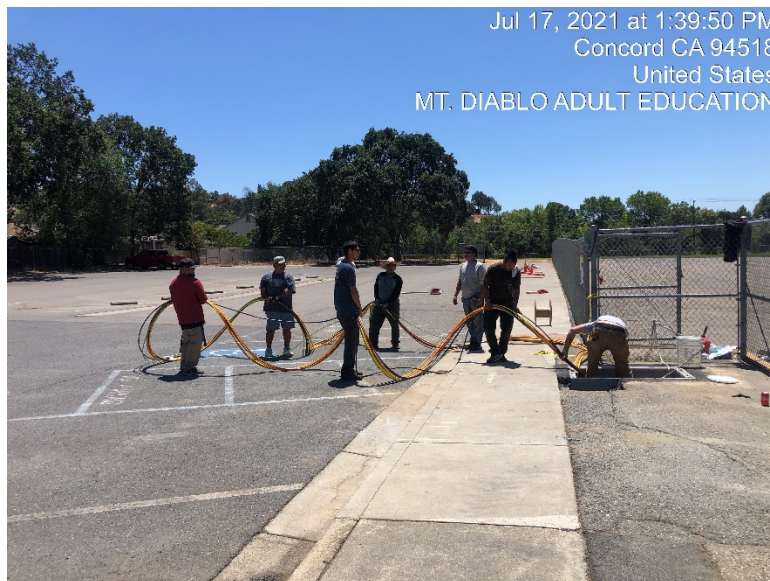
Electricians protecting the sheathing from the ground

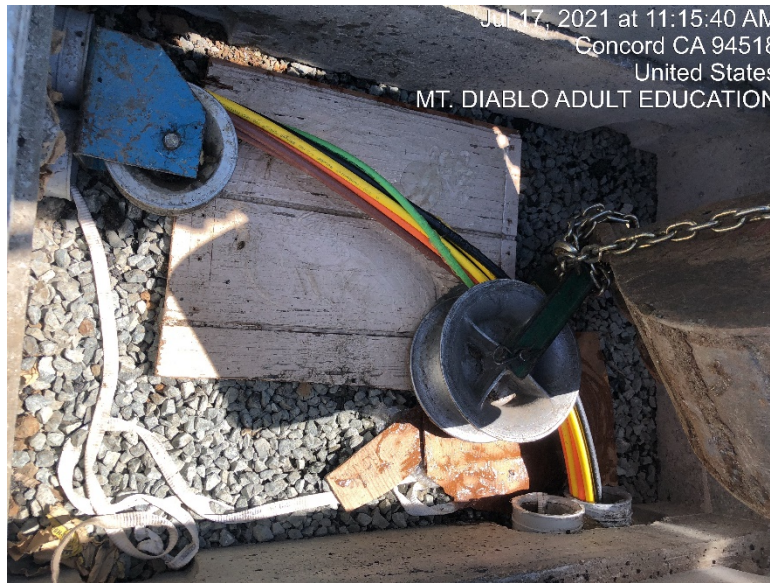
Pt B pullbox (new) with new 500 mcm cables

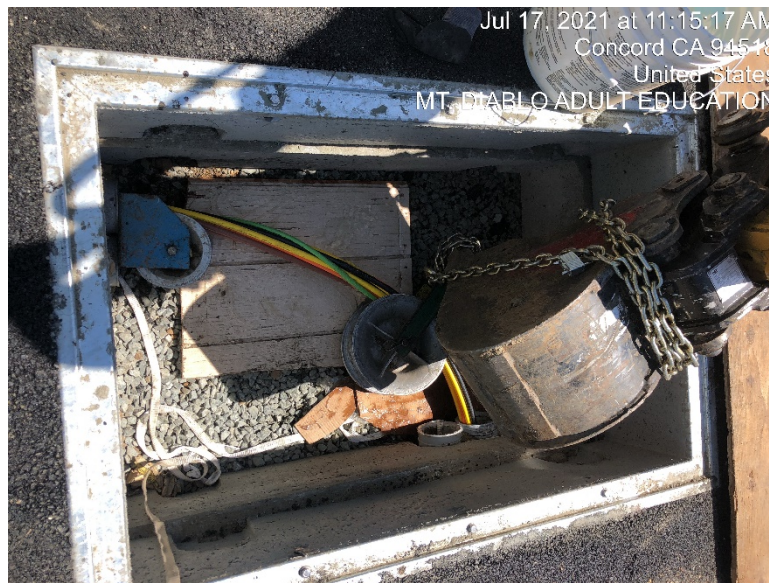
Set up for pulling cable with 45 degree radius bend

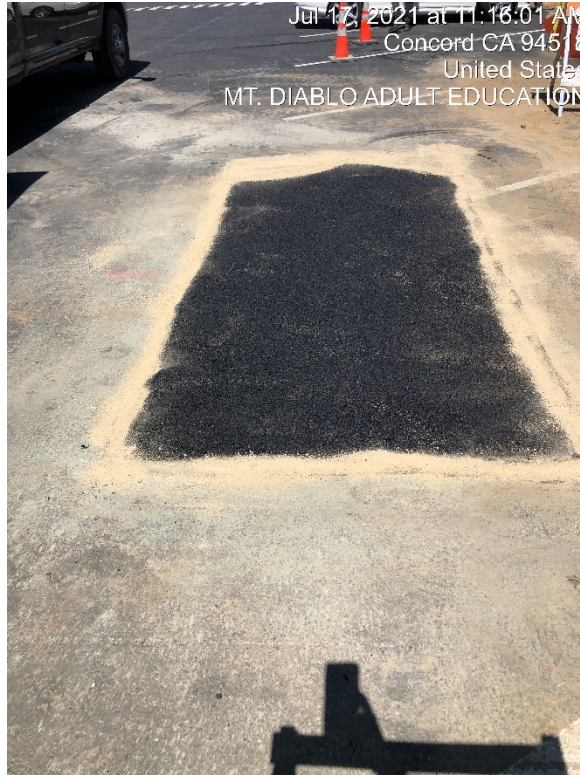
Asphalt patch back where conduit was repaired (2 locations)

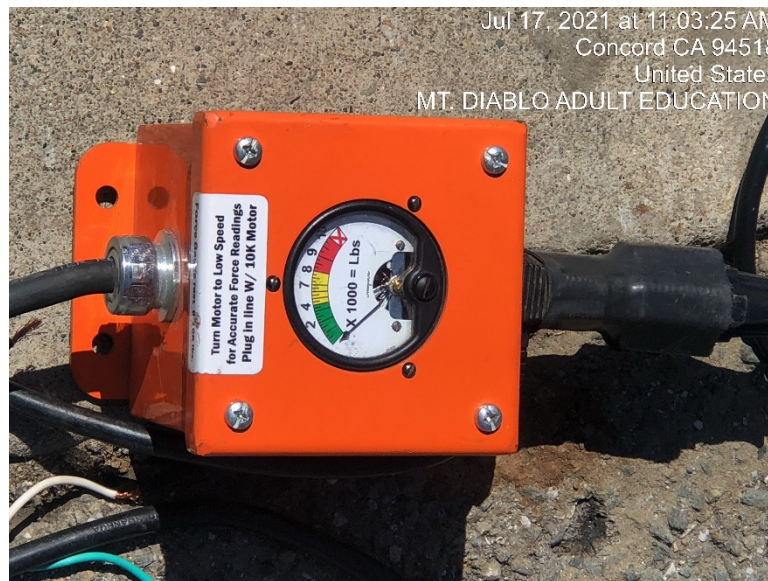
Force meter to monitor force during pulling

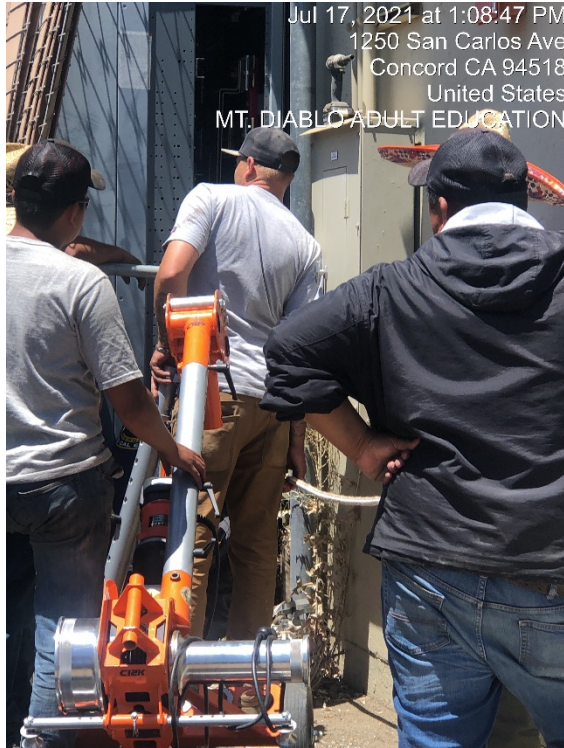
Setting up tugging and pulleys
