Radio Tower at Clayton Valley Charter School

Silke Communications Tower Team performed pre-job walk and site inspection of the existing radio tower at Clayton Valley Charter School. The tower's physical condition renders it unsafe to climb currently.

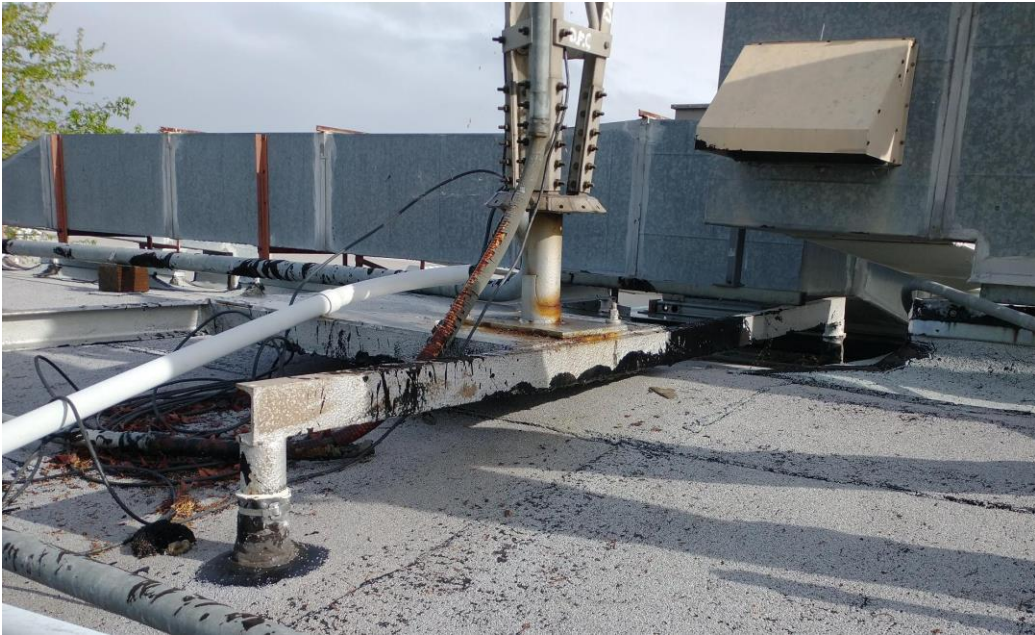
- The tower is leaning in two directions, it must be straightened and aligned.
- The existing guy wires are an old "3 strand" non-specific wire cable. This cable does not have a tensioning specification.
- The existing guy wire turnbuckles have been tightened to the limits and no further adjustment is possible. Some turnbuckle ends have been roofed over in past roofing projects. Guy wires cannot be tightened.
- The guy wire anchors appear to be standard 3/8<sup>th</sup> inch eye-lag bolts screwed into a deteriorating wooden roof.
- The tower's single point base mounting cup and plate are secured with only two bolts, of the four bolt positions, and the mounting cup needs to be inspected to ensure it is per specification.
- The "tower to roof" support structure is showing signs of deflection from the weight and tension of the tower.

***Deflection in tower support mounting frame***

Silke Communications strongly recommends the tower and building be inspected by a California Licensed Structural Engineer to review the existing tower's specifications, installation method of tower to the building and current condition of tower and tower mounting.

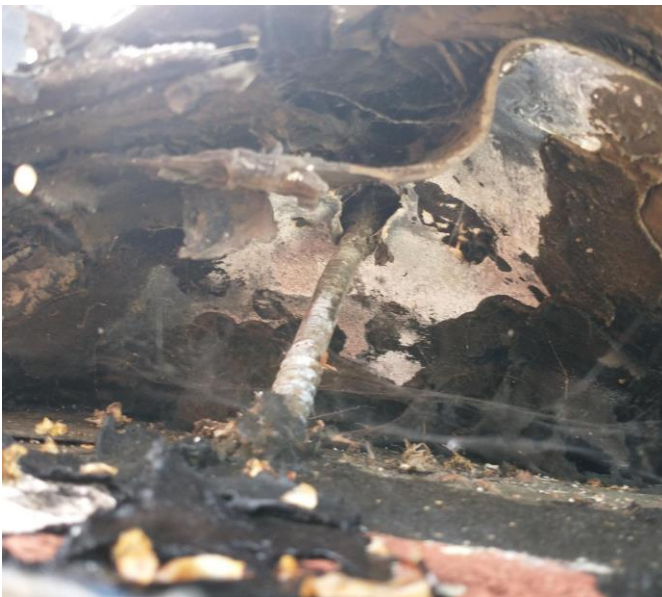
***Guy wire anchor pulling out of roof.***

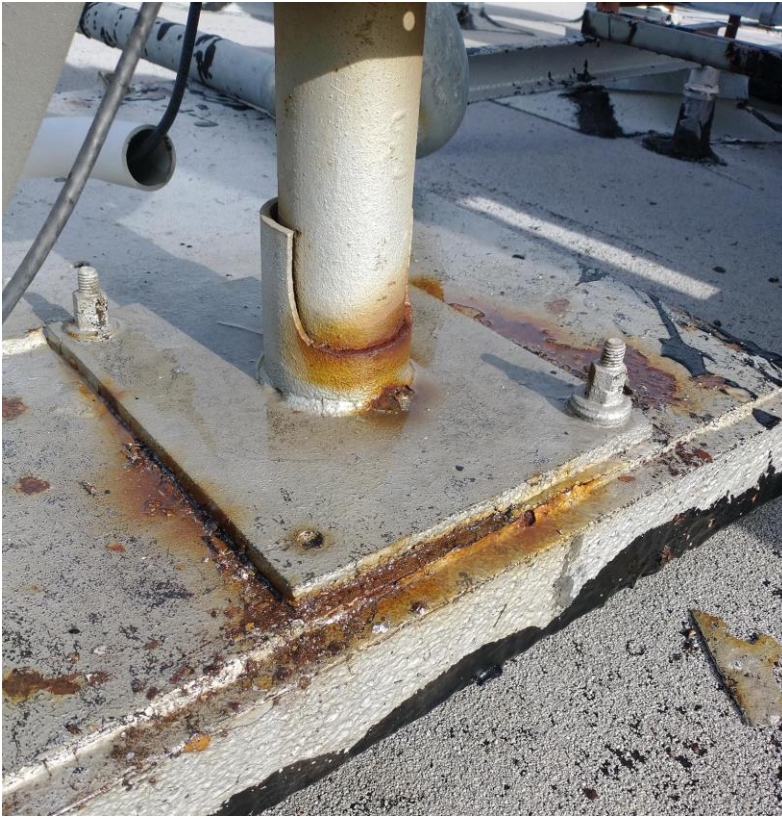
***Tower mounting plate with two bolts and tower receiving cup***

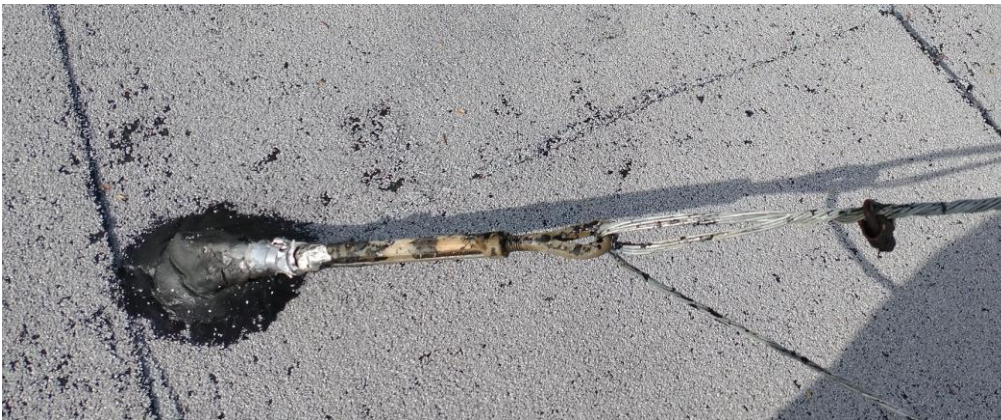
***Non-Accessible turnbuckle and single cable clamp.***
